Re: Seepage Inspection  
Little Falls Dam  
Willow River State Park

Ayres Associates completed a seepage evaluation at the Little Falls Dam in Willow River State Park. The purpose of this evaluation was to observe, quantify and qualify seepage at the Little Falls Dam prior to the planned drawdown.

G1.1 EXISTING CONDITIONS - SEEPAGE INDICATED

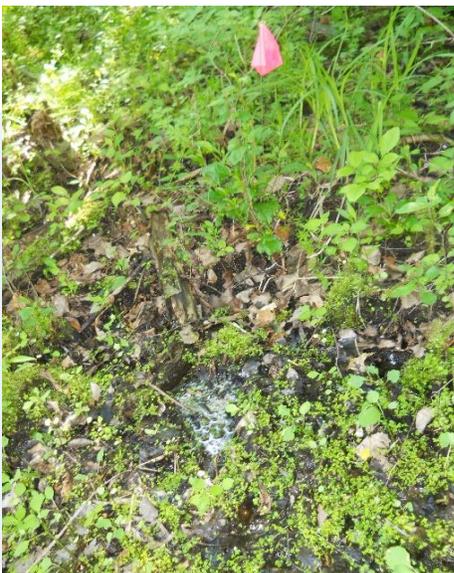
### **Seepage Area 1 – Flowing Seepage Downstream of Riprap on Left Downstream Embankment**

This area consists of saturated soils and standing water with minimal flow. No observed boils or sediment movement were noted. We flagged this area and the photo to the left shows the typical seepage at this location. As noted on Figure 1 there is an area of seepage upstream of this area where the soils are saturated but no standing water is present. There is also a slightly elevated area between these two areas that is drier.

The seepage at this location concentrates into a channel as shown on Figure 1 and outlets on the bank of the downstream pool. We quantified this seepage at less than ½ gallon per minute.

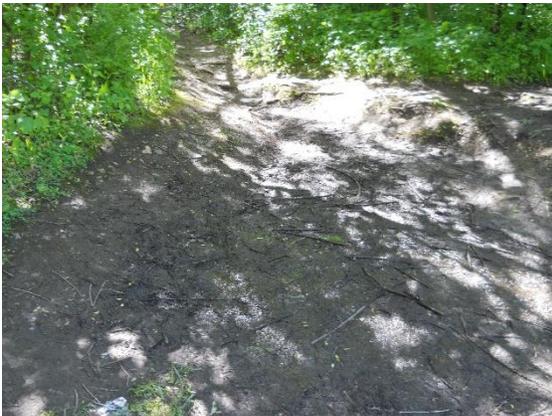
### **Seepage Area 3 – Seepage at End of Foot Path**

This seepage is quite downstream of the dam and is only indicative by a wet spot on the path (see photo to left). It is not from surface drainage as the path is continuously graded to the stream. But due to its distance downstream of the dam we do not believe it is a seepage area of concern.

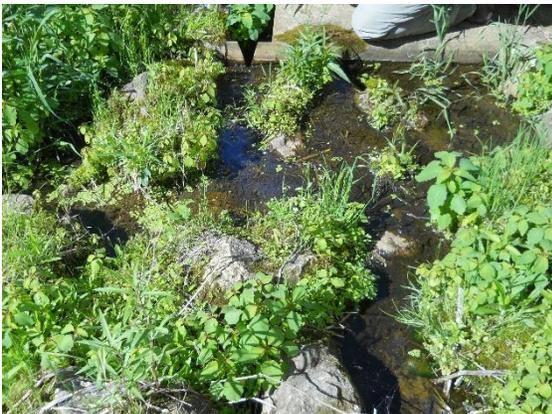
### **Seepage Area 4 – Seepage Measured at Weir Left of Gate 1 Abutment**

A seepage weir box is located downstream of the arch buttress section and adjacent to the abutment for Tainter Gate 1. The foundation under Tainter Gate 1 is an open concrete foundation (hollow) and the standing water is present under this area. The seepage out letting at the weir traces back to the area under Tainter Gate 1. We measured the water surface elevation within the riprap at the highest point and it is the same elevation as the water under Tainter Gate 1.

We measured the weir and the dimensions, shown on Figure 1. On the day of our visit water was flowing 1.25 inches deep in the weir which equals a flow of 1.23 gallons per minute. The seepage in this area was clear.

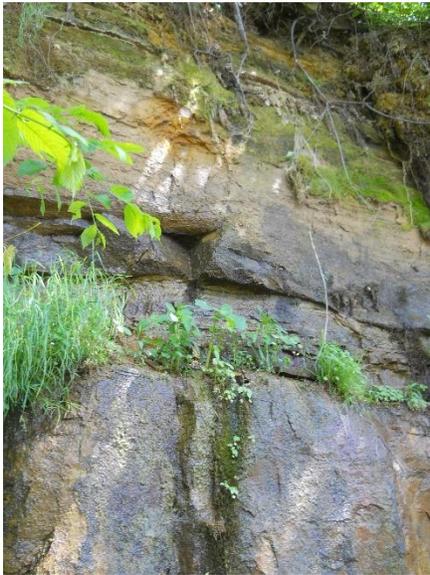
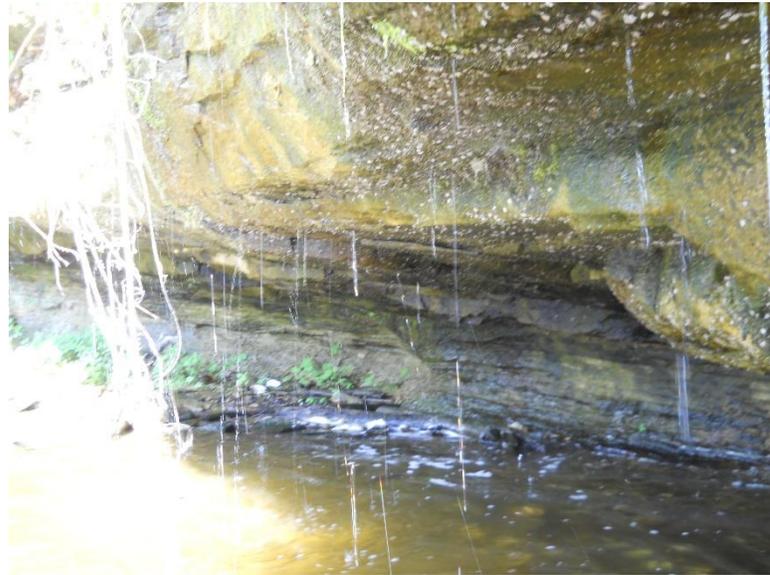
### **Seepage Area 5 – Seepage from Bedrock on Right Downstream Bank**

We observed the seepage existing the bedrock at a point about 12 to 15 feet above the water surface (left photo above). This is about the same elevation, maybe slight higher, than were seepage is exiting the ground on the left downstream embankment. The seepage occurs over about a 30 foot length of bedrock outcrop and is exiting at a more fractured layer of limestone bedrock. The bedrock under this layer is more massive and likely a vertical barrier to water movement and the water daylights above this layer. We did not try to quantify the seepage over this area. According to Mr. Mason this seepage has always been present at this location and is quite apparent in the winter due to ice formations.

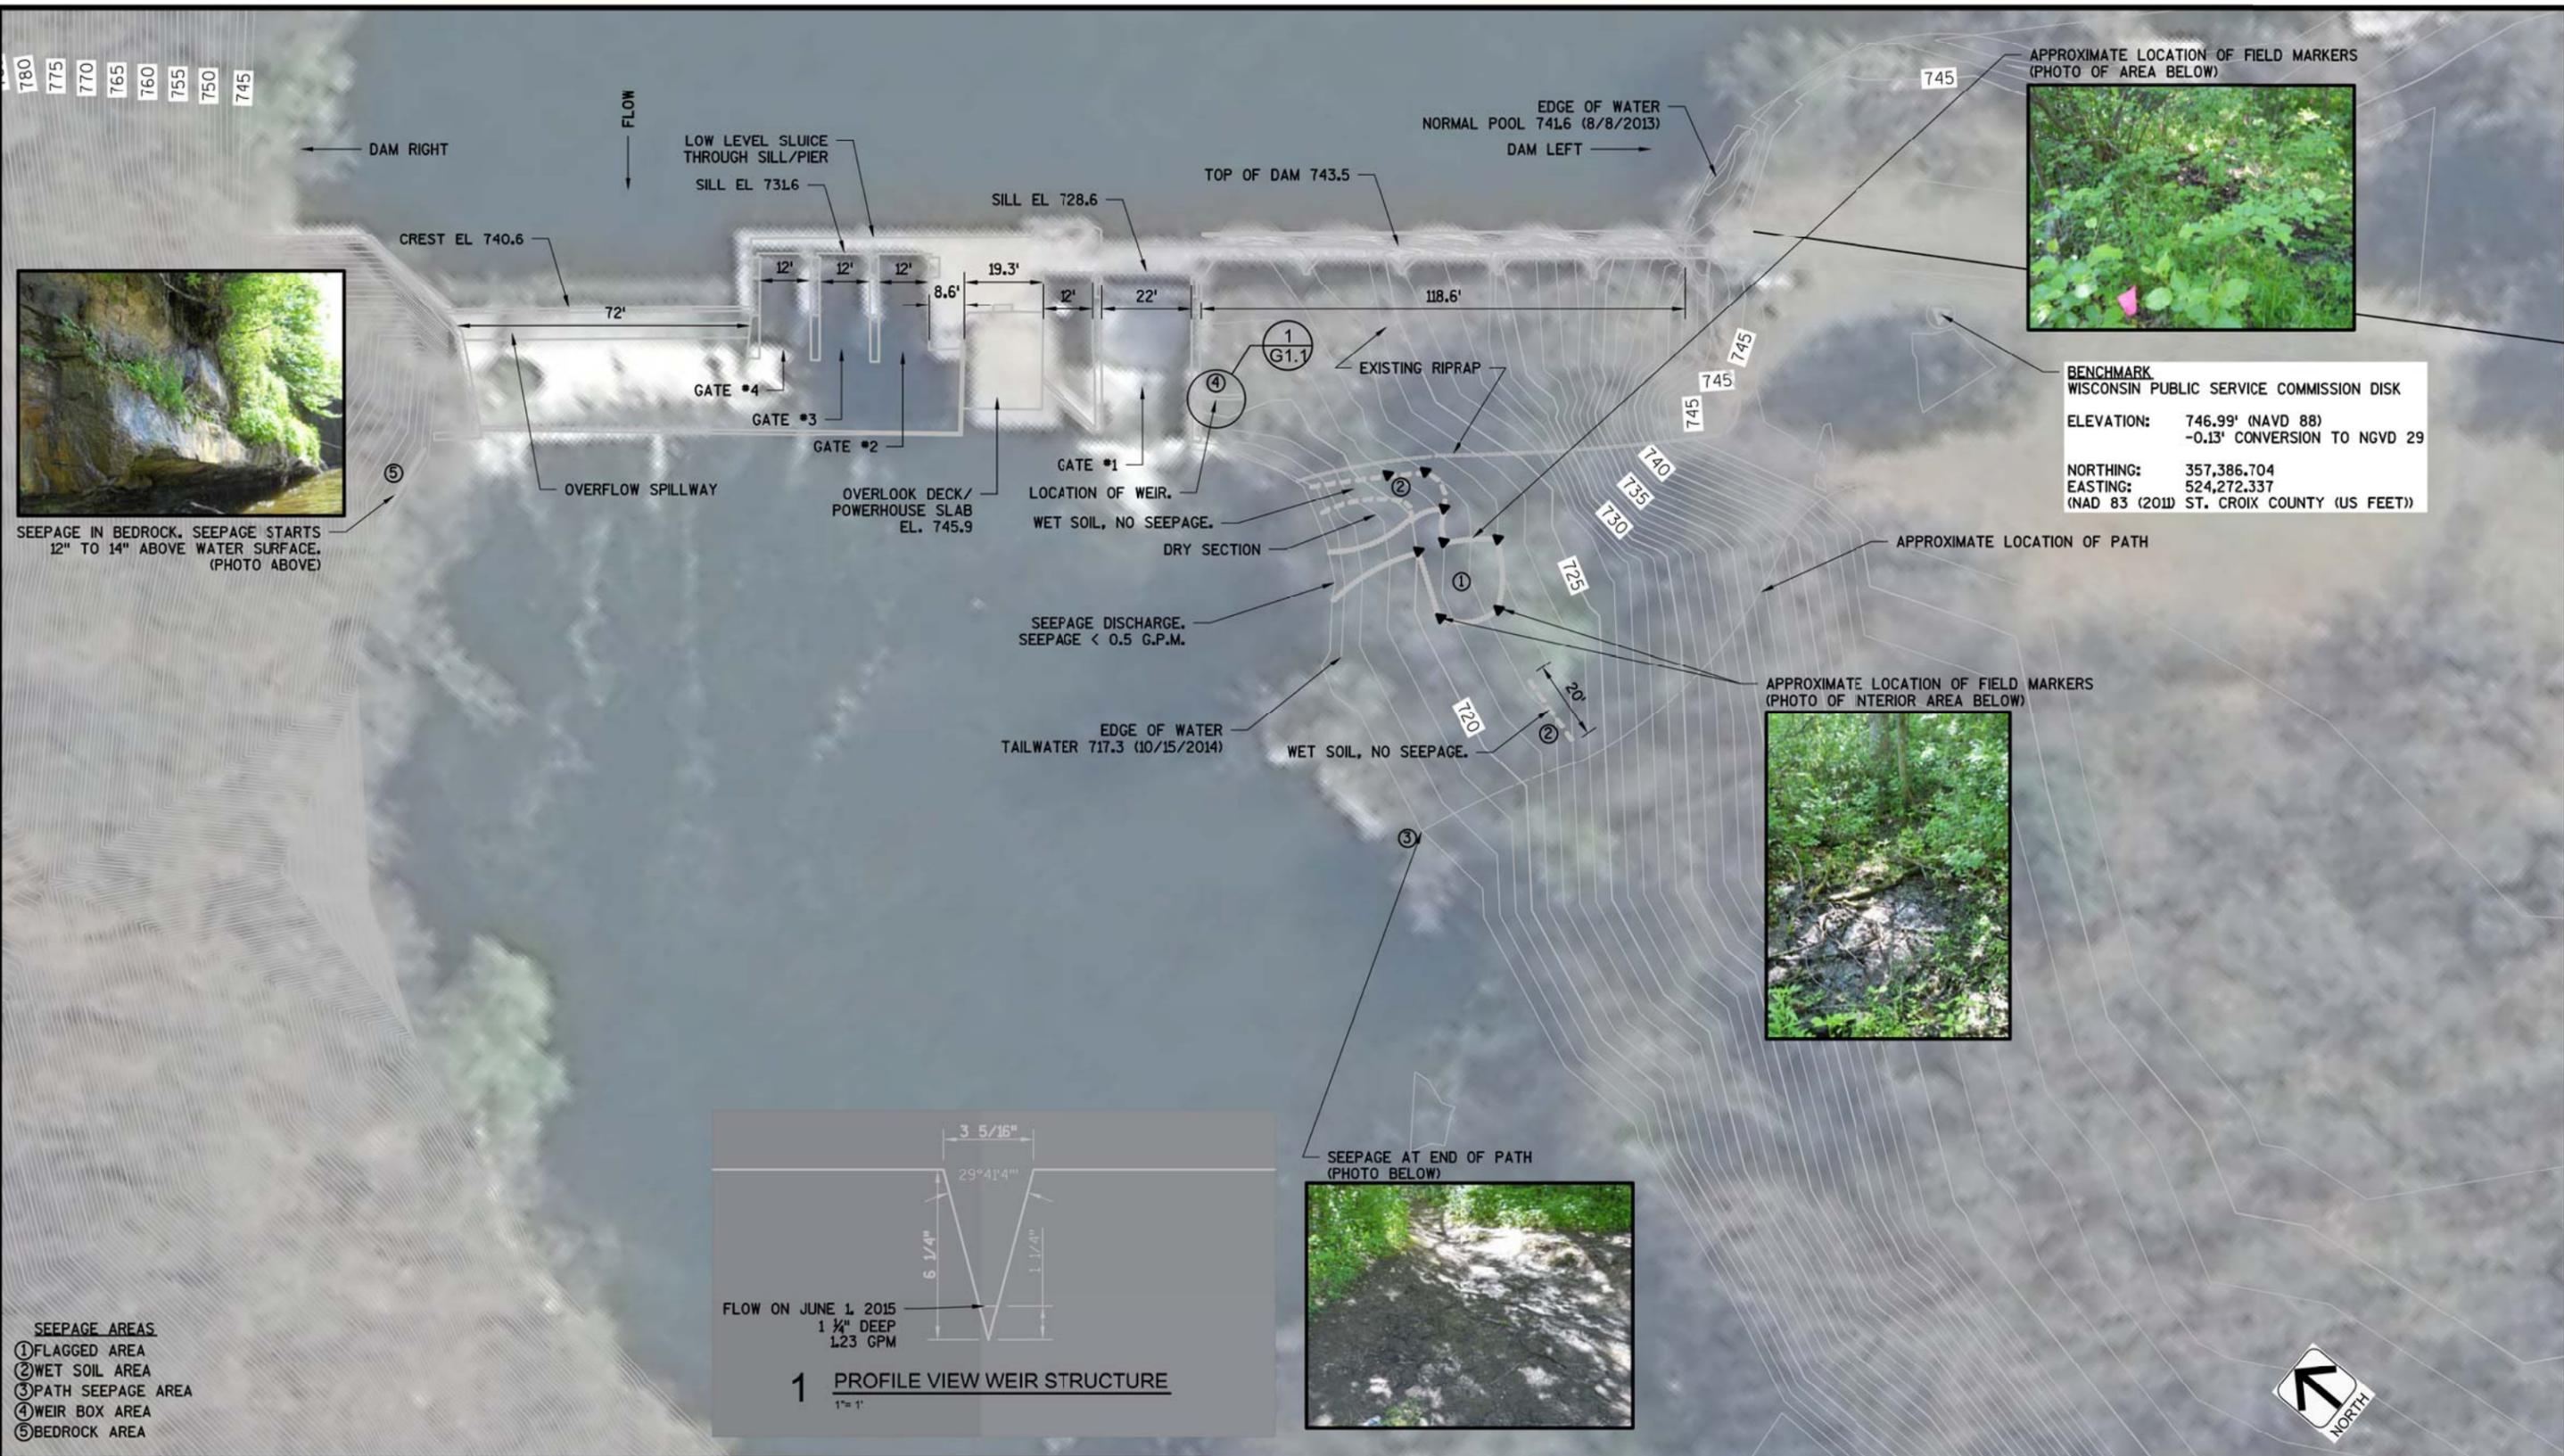
This seepage is noted as wet soil seepage on Figure 1 and no standing water or water at the surface was observed. As shown on Figure 1, it is about the same elevation as the flagged seepage upstream, but is not exiting at the surface. We did not map out this area, only noted its location on Figure 1.

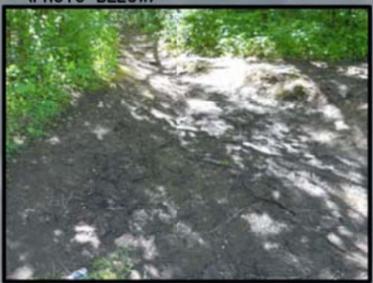
SEEPAGE AT END OF PATH  
(PHOTO BELOW)
