East Twin River Baseline Monitoring Report

By Steve Hogler and Jim Cahow

ABSTRACT

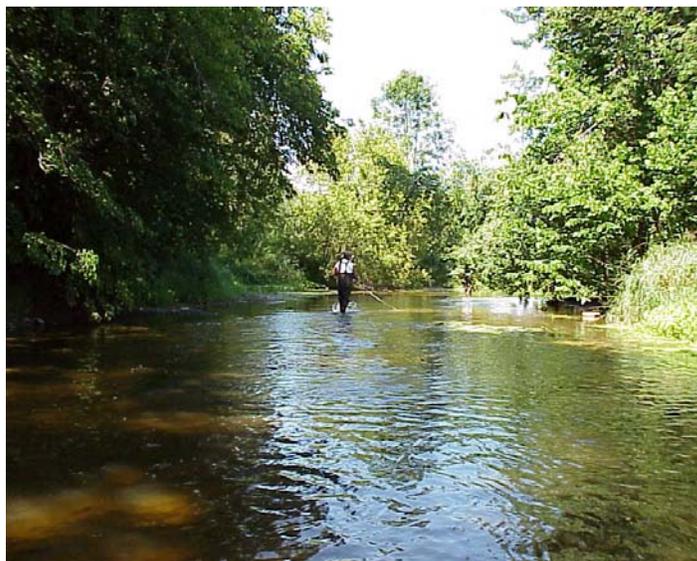
This site was located just downstream of the village of Mishicot (N44-13.279, W087-37.384 to N44- 13.431, W087- 37.435). The survey section averaged 12 meters in width and was 420 meters in length (Appendix 1). The gradient was 1.4 meters per kilometer and had a sinuosity of 1 to 1.4. The study reach of the river ran through agricultural and some residential lands and was mostly run with several pools located at stream bends (Figure 3).

Figure 3. Looking upstream from Steiners Corners on August 14, 2001. Note that the stream is wide and shallow at this location.

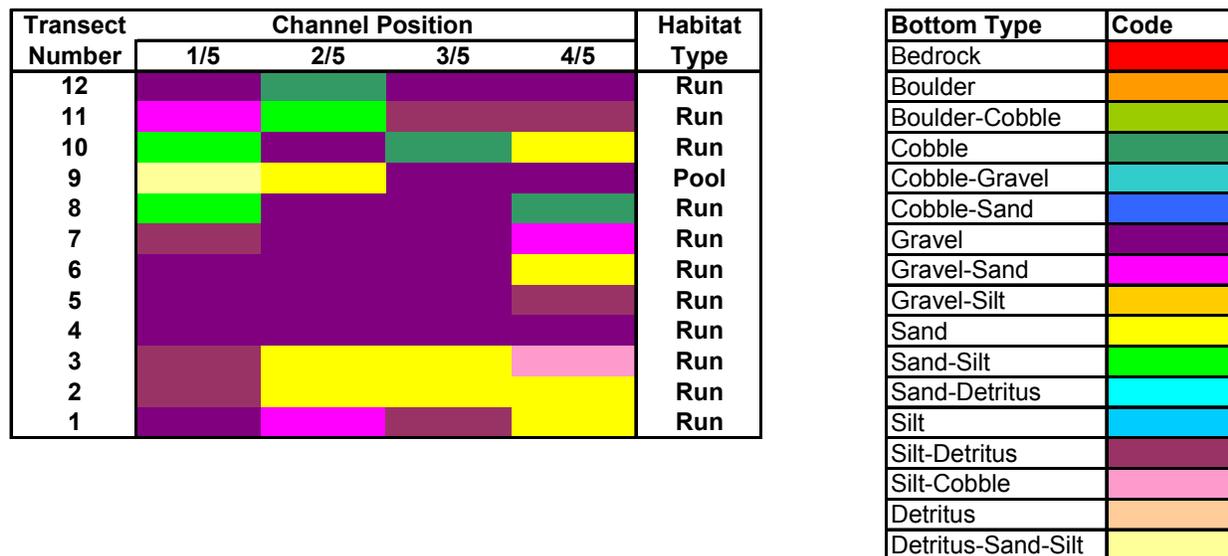
The bottom sediments were dominated by gravel, although large areas of sand were encountered (Figure 4). Sand in the lower transects of the station was replaced by gravel, followed by an increase in sand-silt combinations as we moved upstream.

Figure 4. Bottom sediment map and key for transects at the Steiners Corner station. Transect 1 is the furthest downstream sampling location.

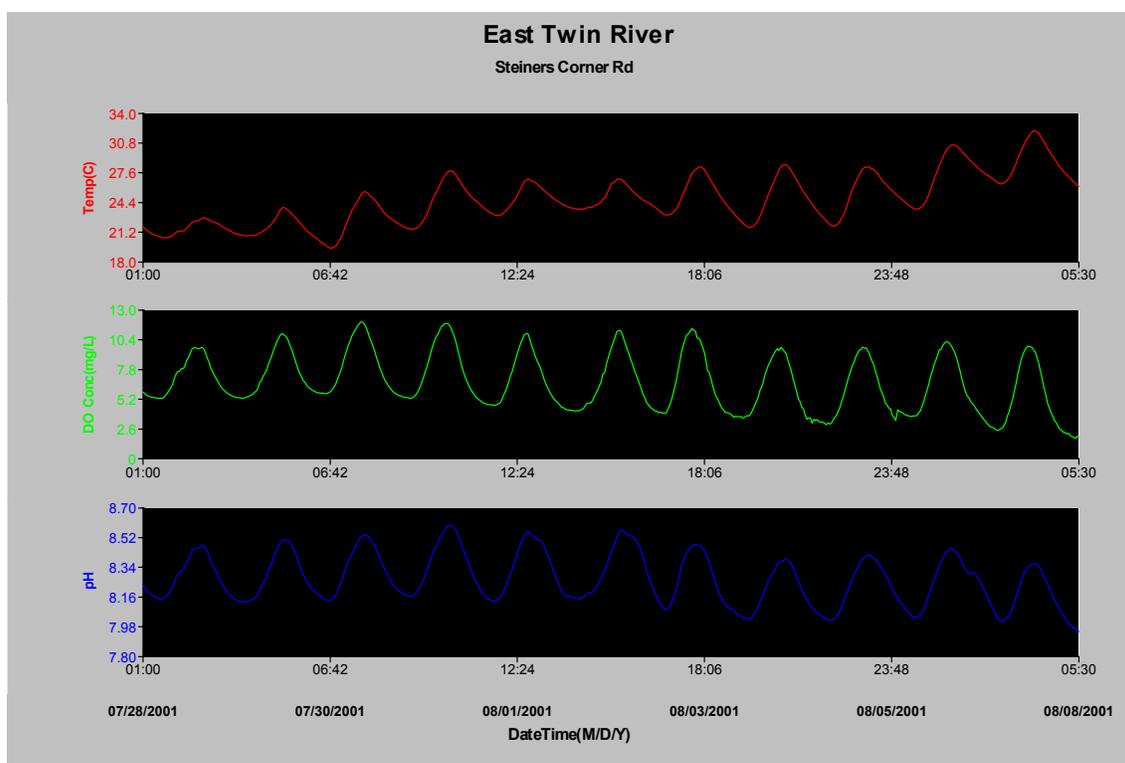
Figure 5 documents the diurnal temperature, dissolved oxygen, and pH for the East Twin River below the Mishicot impoundment near Steiner's Corner Road during August of 2001. The dissolved oxygen profile shows that there are dramatic swings in the amount of D.O. each day, with some values below levels (5.0 mg/l) needed to support sensitive aquatic organisms. Temperature and pH appeared to be normal for the river and time of year.

Figure 5. Diurnal temperature, dissolved oxygen, and pH for the East Twin River below the Mishicot impoundment near Steiner's Corner Road during August of 2001.

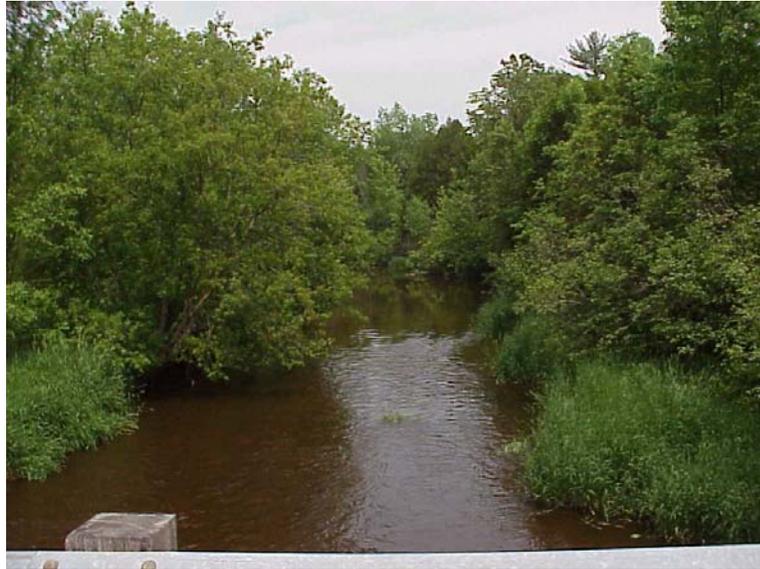
This site was located just upstream of the village of Mishicot millpond (N44-15.663, W087- 39.596 to N44- 15.855, W087- 39.706). The survey section averaged 12 meters in width and was 420 meters in length (Appendix 1). The gradient was 2.2 meters per kilometer and had a sinuosity of 1 to 1.1. The study reach of the river ran through agricultural land and was mostly run with several large pools located at stream bends (Figure 6).

Figure 6. Looking upstream on the East Twin River from the Rockledge Road bridge.

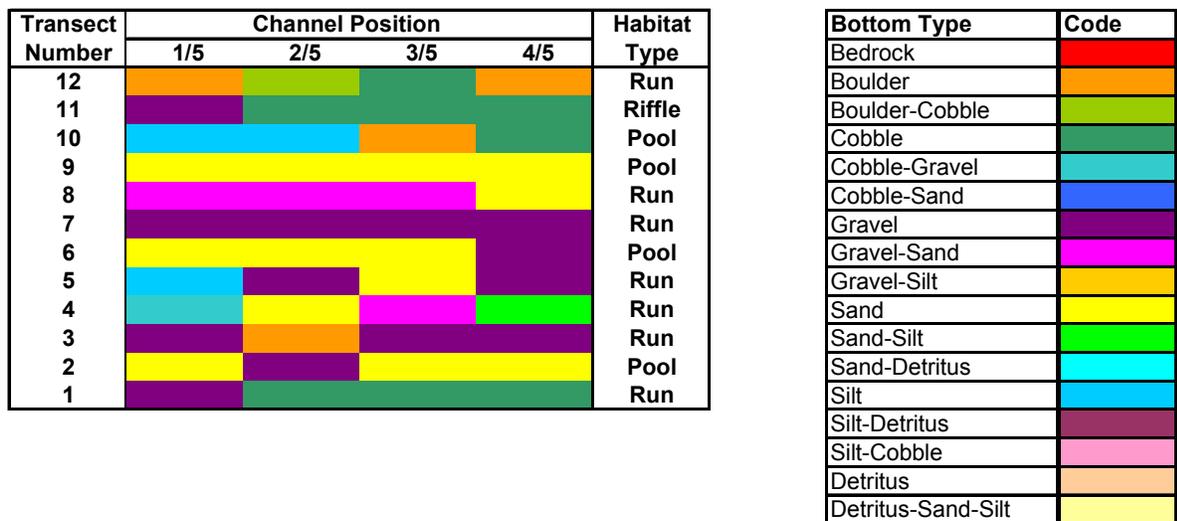
Sand, gravel, or a sand-gravel combination dominated the bottom type of the section (Figure 8). These combinations were very common in the middle transects of the site. However, several large pockets of boulders and cobble were encountered while. Soft sediments, silt and detritus were uncommon at this station.

Figure 8. Bottom sediment map and key for transects at the Rockledge Road station. Transect 1 is the furthest downstream sampling location.

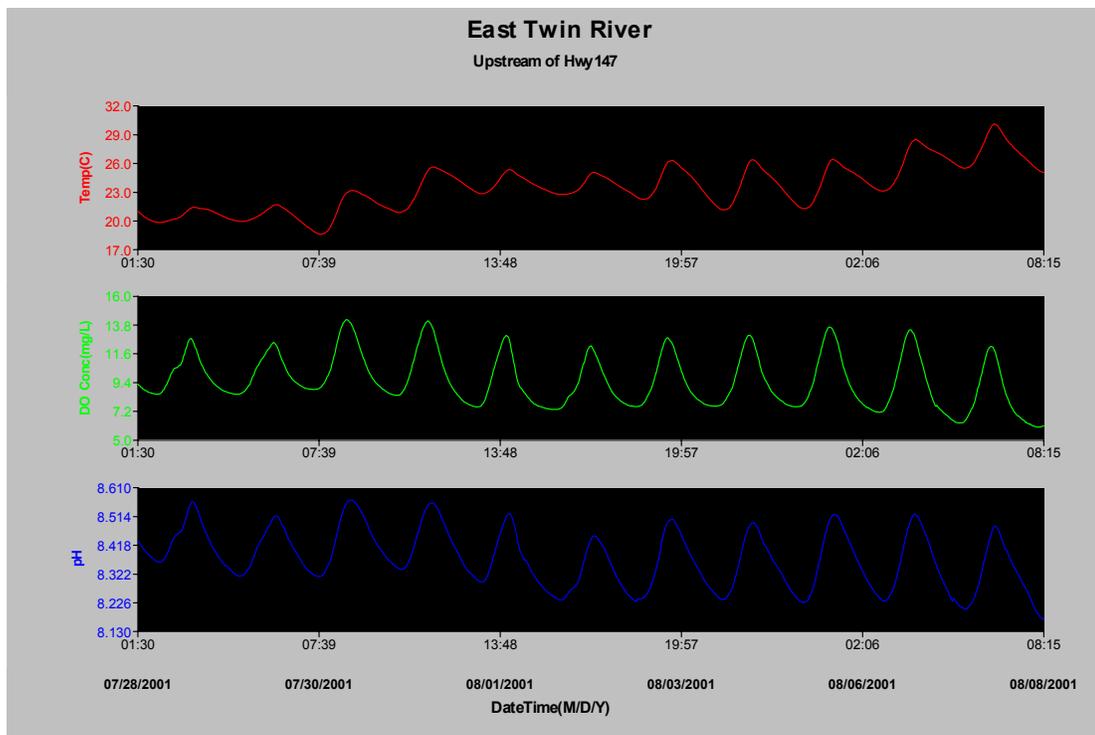
Figure 9 documents the diurnal temperature, dissolved oxygen, and pH for the East Twin River downstream of Rockledge Road during August 2001. Maximum diurnal temperatures continue to be above those that can support trout and other cold water species.

Figure 9. Diurnal temperature, dissolved oxygen, and pH for the East Twin River downstream of Rockledge Road during August 2001.

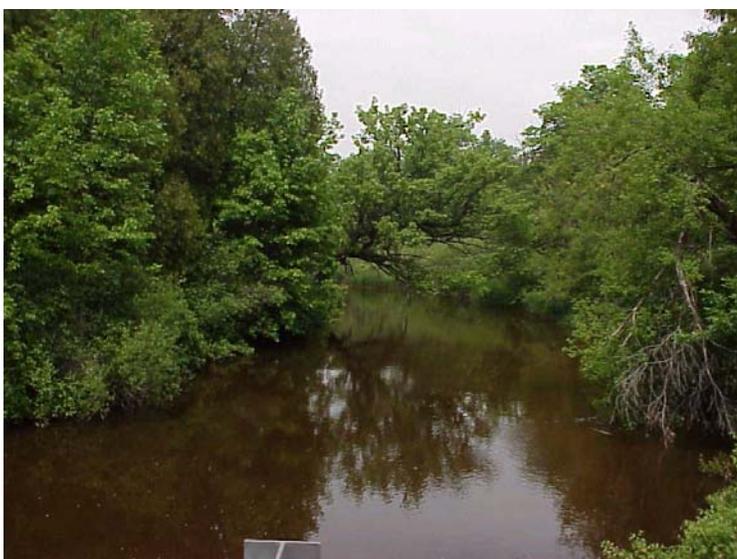
This site was located downstream of Tapawingo Road, and ran through Camp Tapawingo (N44-16.855, W087-39.788 to N44-17.025, W087-39.549). The survey section averaged 15.76 meters in width and was 467 meters in length (Appendix 1). The gradient was 1.9 meters per kilometer and had a sinuosity of 1 to 1.4. The study reach of the river flowed through a mostly wooded area and had nearly equal amounts of run, riffle and pool habitat (Figure 10). One large island was found in the study section.

Figure 10. The East Twin River looking downstream from Tapawingo Road on June 13, 2002. Most of the site was forested as can be seen from this photograph.

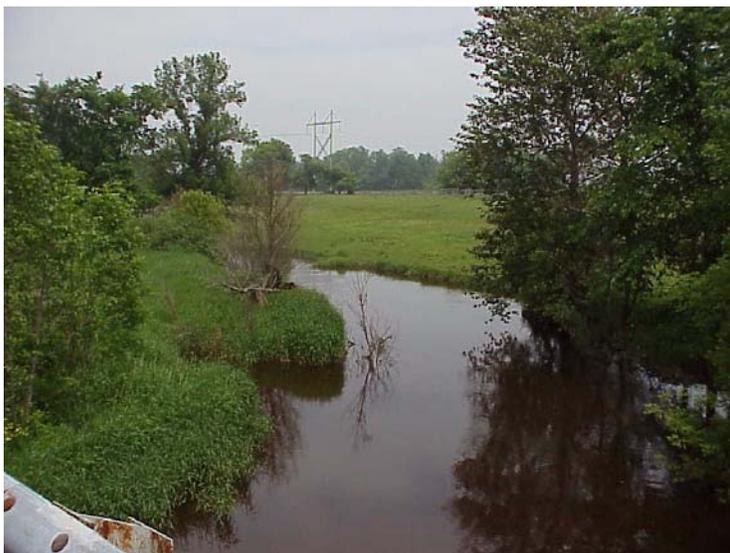
This site was located just upstream of County Highway AB, and ran through mostly pasture land (N44-18.466, W087- 38.647 to N44-18.609, W087- 38.559). The survey section averaged 9.4 meters in width and was 315 meters in length (Appendix 1). The gradient was 1.9 meters per kilometer and had a sinuosity of 1 to 1.09. The study reach of the river was predominantly run, with several small pools and only one riffle (Figure 12).

Figure 12. Looking upstream from the Highway AB bridge over the East Twin River.

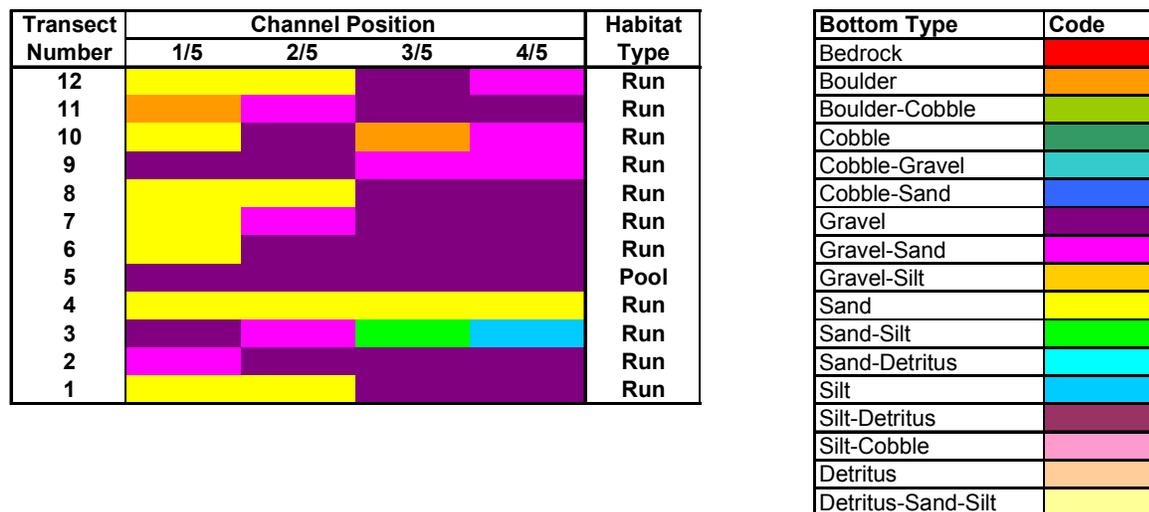
Gravel, sand or gravel-sand combinations dominated bottom substrate in this section (Table 13). Other than the two boulder patches in transect 10 and 11 and the silt in transect 3, the bottom was flat and fairly monotypic.

Figure 13. Bottom sediment map and key for transects at the County Highway AB station. Transect 1 is the furthest downstream sampling location.

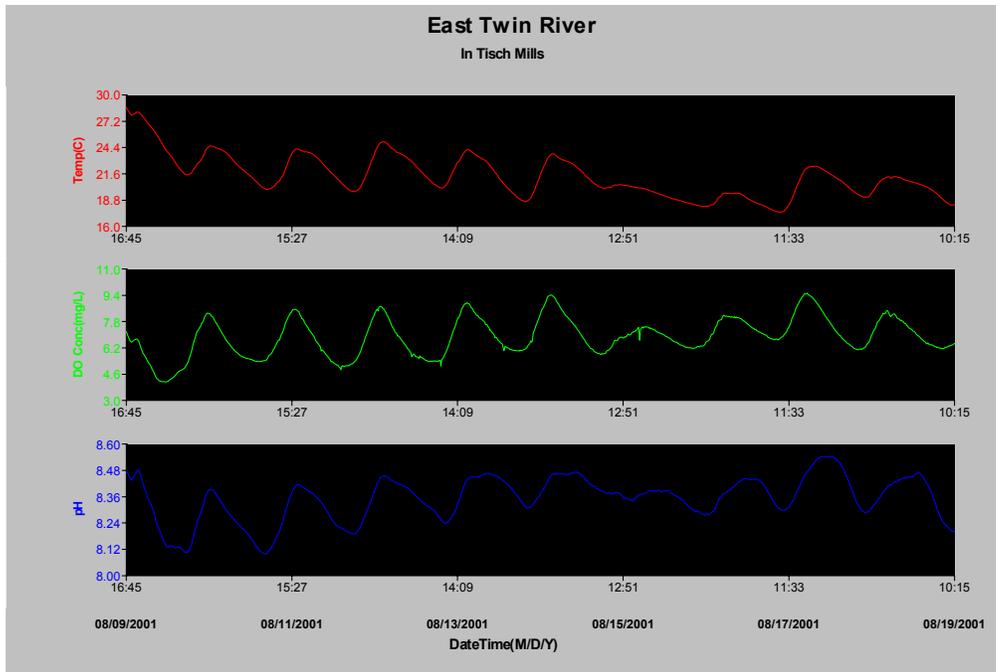
Figure 14 documents the diurnal temperature, dissolved oxygen, and pH for the East Twin River near Tisch Mills during August of 2001. The diurnal temperatures approached 30 degrees Centigrade, which is well beyond those capable of supporting trout and some species of gamefish. Dissolved oxygen levels dropped below 5 mg/L following a minor runoff event and probably drop much lower with heavier runoff events or during drought conditions with warmer than average summer temperatures.

Figure 14, diurnal temperature, dissolved oxygen, and pH for the East Twin River near Tisch Mills during August of 2001.

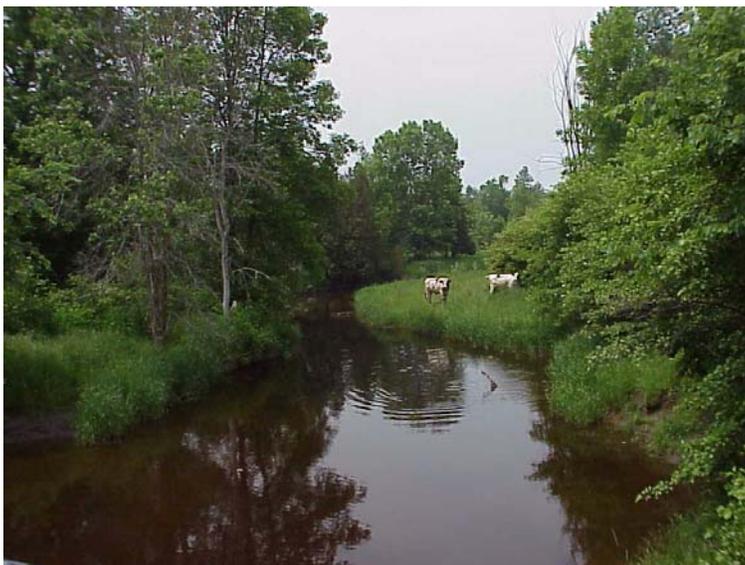
This site was located just upstream of Sandy Bay Road, and ran through mostly pasture land on one bank and meadow on the opposite bank (N44-21.410, W087-36.029 to N44-21.585, W087-35.016). The survey section averaged 8.5 meters in width and was 297.5 meters in length (Appendix 1). The gradient was 5.1 meters per kilometer and had a sinuosity of 1 to 1.07. The study reach of the river was a series of pools and runs (Figure 15). No riffle areas were encountered at this site.

Figure 15. The East Twin River, looking upstream from the bridge on Sandy Bay Road. Stream bank use by pasturing cows was observed at this location.

Bare soil and stream bank erosion was noted at most transects in this study section. Pasturing of cattle along the stream bank was the likely cause for the impacted banks in this section of river.

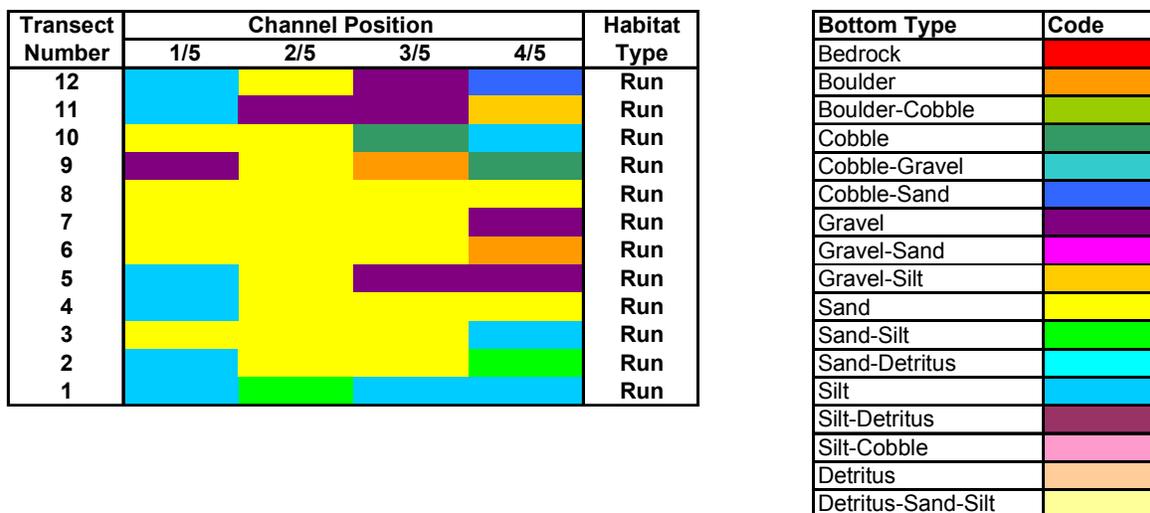
Sand, sand/detritus or sand/silt mixtures dominated the bottom substrate at this location (Figure 16). Few locations along the stream transects contained substantial amounts of hard substrates in the form of gravel, cobble or boulders which limited the amount of fish habitat available at this site.

Figure 16. Bottom sediment map and key for transects at the Sandy Bay Road station. Transect 1 is the furthest downstream sampling location.

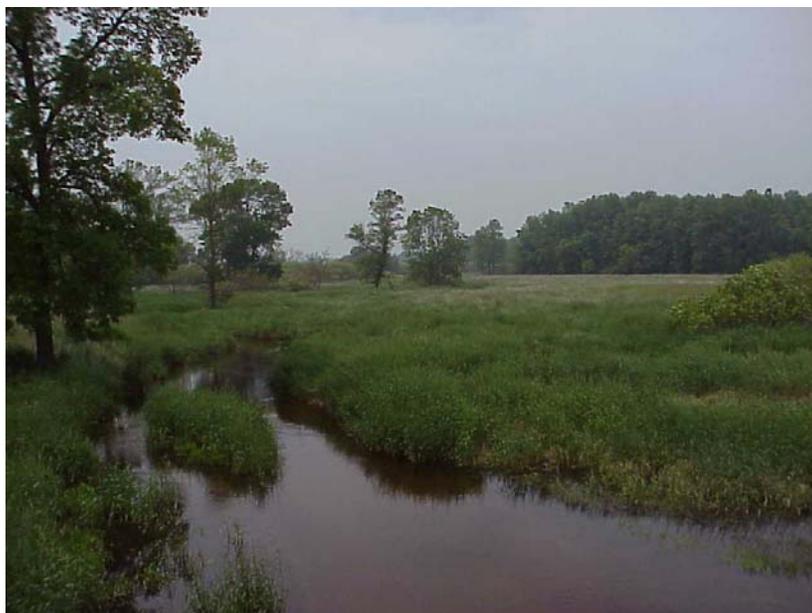
1). The gradient was 6.5 meters per kilometer and had a sinuosity of 1 to 2.5. The study reach of the river was a series of pools and runs with one small riffle (Figure 17).

Figure 17. The East Twin River, looking upstream from the bridge on County Highway B.

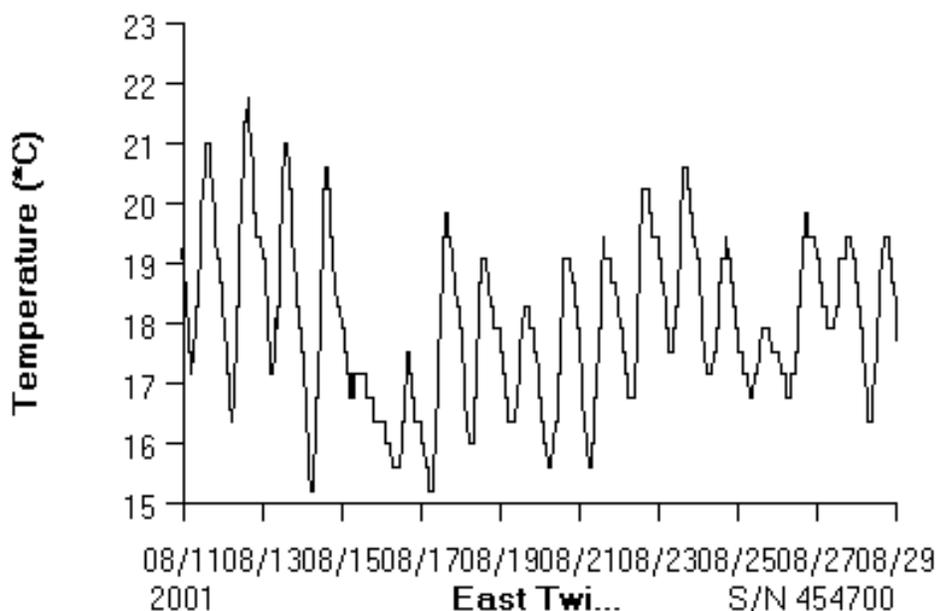
Figure 19, documents the diurnal temperature for a section of the East Twin River at County Highway B approximately 5-6 miles downstream from the headwaters of the river. Since stocked brown trout were observed in the sampling station and appeared to have survived and grown 1-2 years since stocking, this would indicate that temperature and dissolved oxygen levels did not preclude survival of coldwater species during the immediate years preceding the survey. Temperature never exceeded 22 C. during the survey period.

Figure 19, diurnal temperature for a section of the East Twin River at CTH B, upstream of confluence with un-named tributary flowing out of East Krok, August 2001.

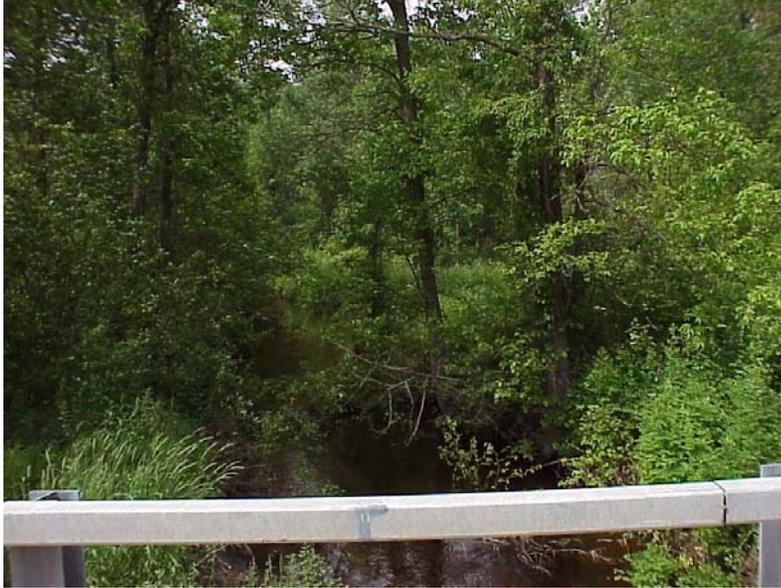
The study reach of the river was a series of pools and runs without any riffles (Figure 20).

Figure 20. The East Twin River, looking upstream from the bridge on County Highway J.

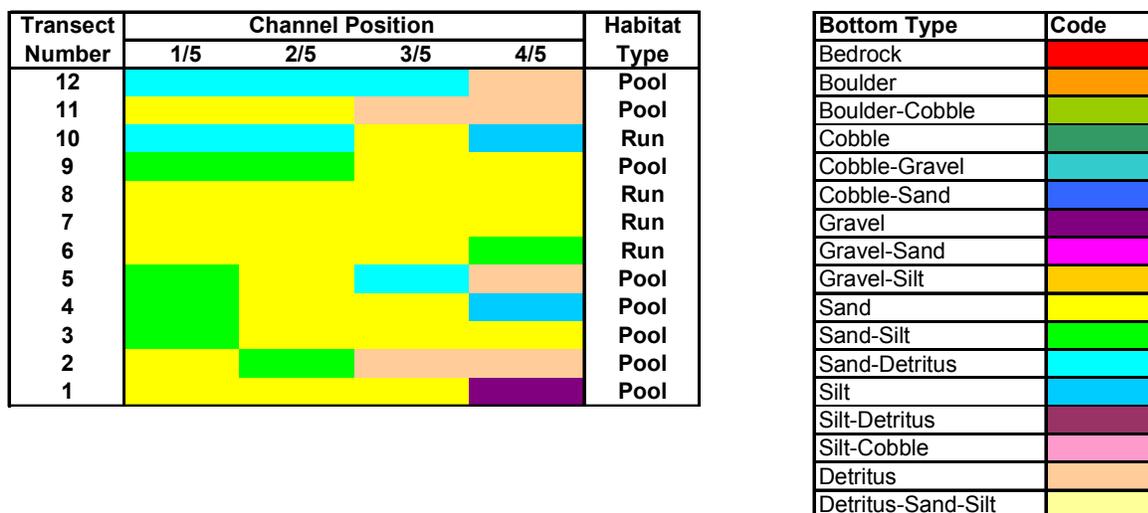
The bottom sediments at this site were dominated by sand. Small pockets of detritus, silt and gravel were encountered but in many cases, these also had sand in the mixture.

Figure 21. Bottom sediment map and key for transects at the County Highway J station. Transect 1 is the furthest downstream sampling location.

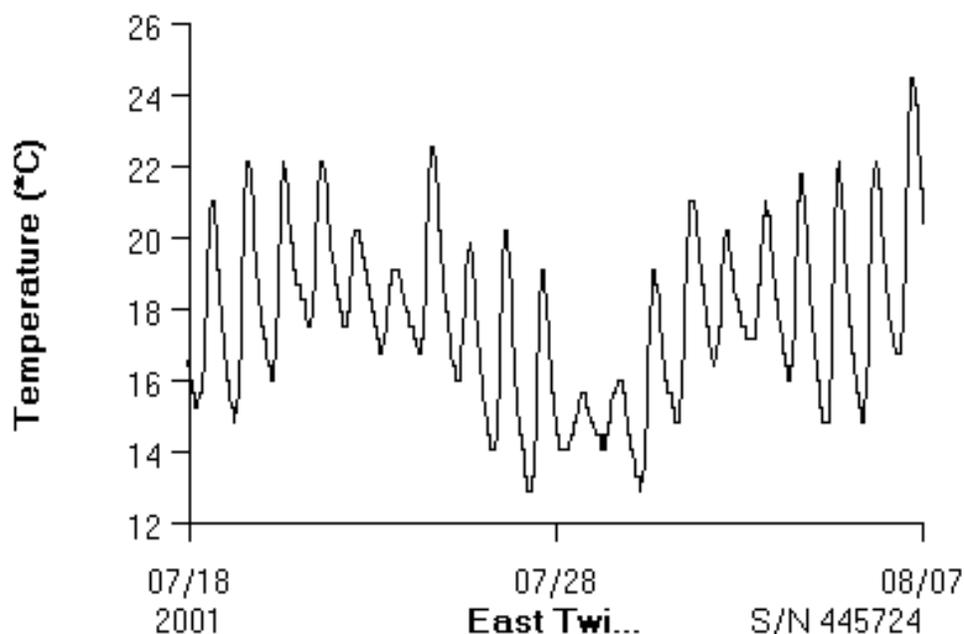
Figure 22, documents the diurnal temperature for a section of the East Twin River at Krok Road, approximately 2 kilometers upstream of Highway J during August of 2001. Maximum diurnal temperatures reached 24 Centigrade. The section of the East Twin River between Highway 29 and Krok Road lacks adequate buffer widths and composition which results in a lack of forest canopy. This lack of forest canopy resulted in more sunlight reaching the stream and increased water temperatures in the stream.

Figure 22. Diurnal temperatures for the East Twin River at Krok Road, approximately 2 kilometers upstream of County Highway J, during August of 2001.

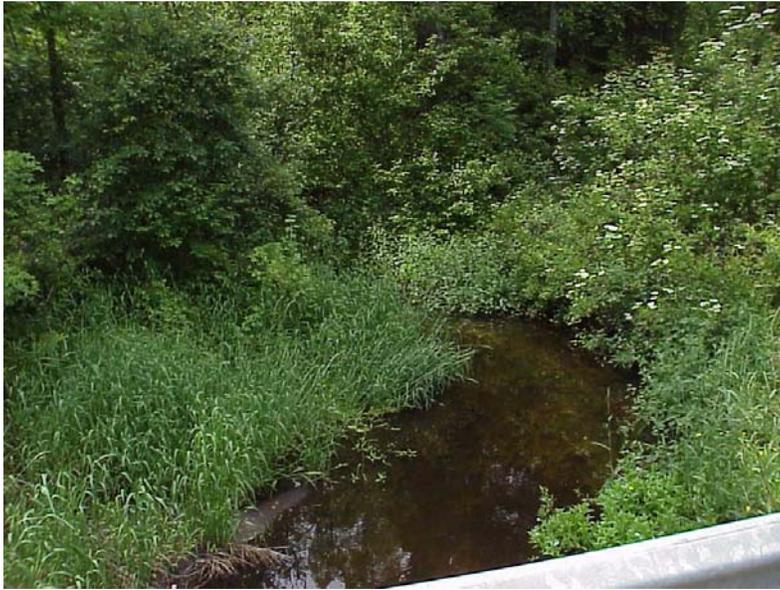
of the river consisted of one long run, several small runs and pools and one riffle (Figure 23).

Figure 23. The East Twin River, looking upstream from the bridge on Townline Road.

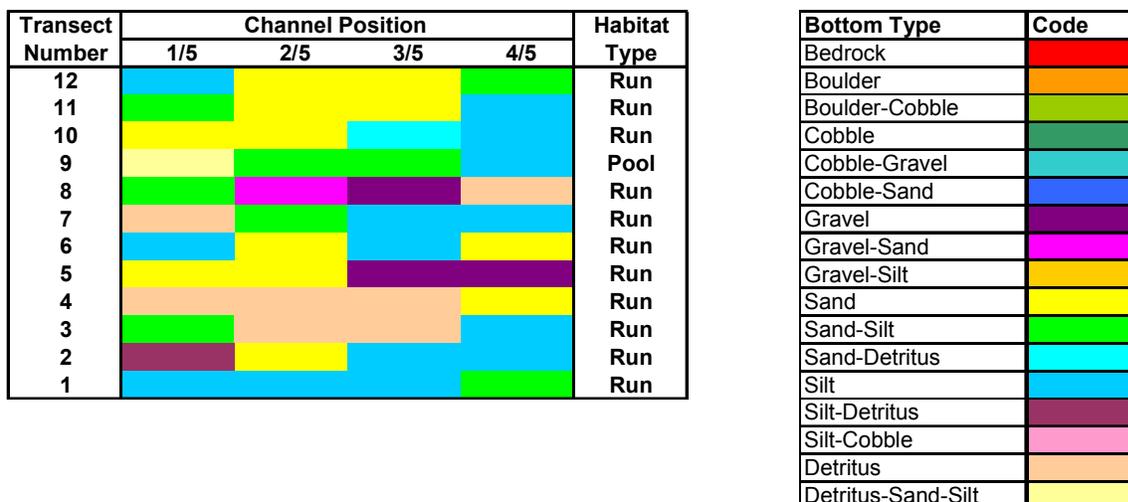
Similar to the study site at Highway J, the bottom sediments at this site were dominated by sand, or sand mixtures (Figure 24). Some small deposits of detritus and gravel were encountered, but they were not widespread at the site.

Figure 24. Bottom sediment map and key for transects at the Townline Road station. Transect 1 is the furthest downstream sampling location.

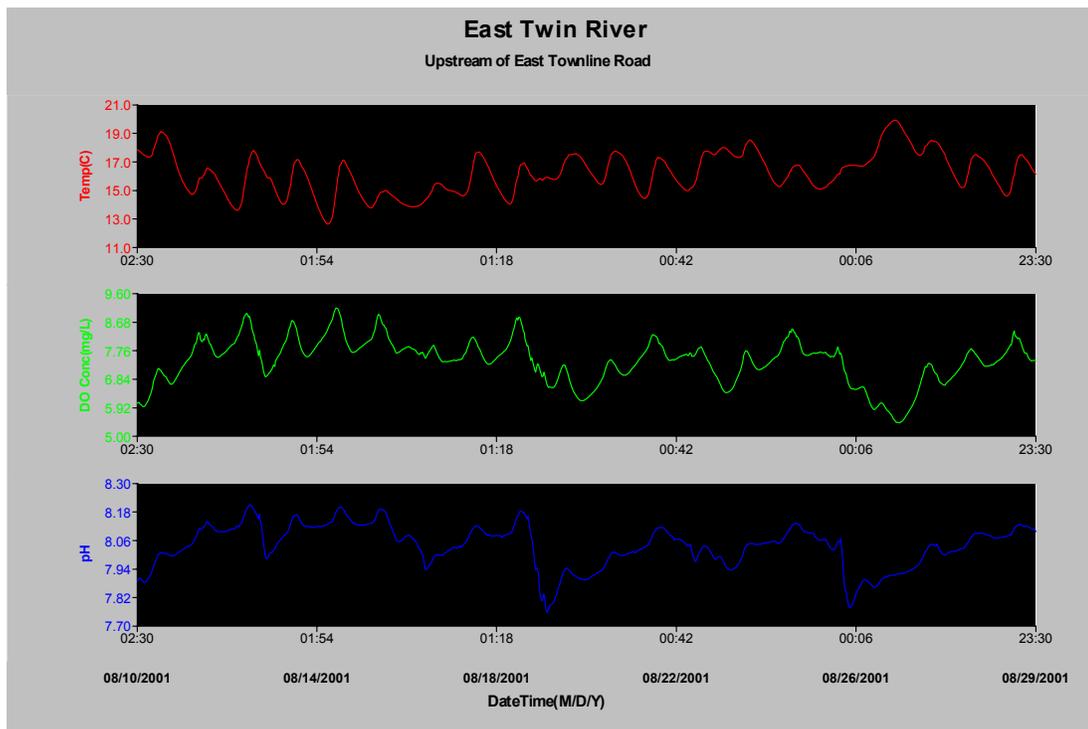
Figure 25 documents the diurnal temperature, dissolved oxygen, and pH for more than two weeks in the headwaters of the East Twin River, near East Townline Road during August of 2001. This stream segment was found to have summer diurnal temperatures which seldom increased above 20 Centigrade (Figure 25). Dissolved oxygen levels did drop below 6 mg/L during the study; but averaged closer to 7 mg/L for the majority of the period monitored. This short section of the stream has good stream buffers and along with a dense forest canopy, helped to maintain colder water temperatures with good D.O. levels.

Figure 25. Diurnal temperature, dissolved oxygen, and pH for the East Twin River at East Townline Road, August of 2001.

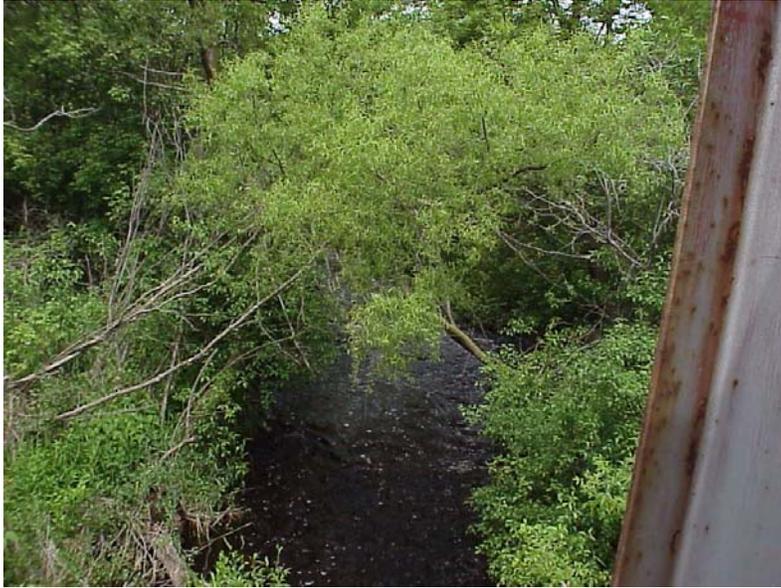
This site was located just upstream of Jambo Creek Road, and ran through mostly shrubs and woodland (N44-15.743, W087-40.882 to N44-15.832, W087-40.900). The survey section averaged 5.4 meters in width and was 189 meters in length (Appendix 1). The gradient was 1.6 meters per kilometer and had a sinuosity of 1 to 1.1. The study reach of the river was most pool and run with a lesser amount of riffle (Figure 26).

Figure 26. Jambo Creek, looking upstream from the bridge on Jambo Creek Road.

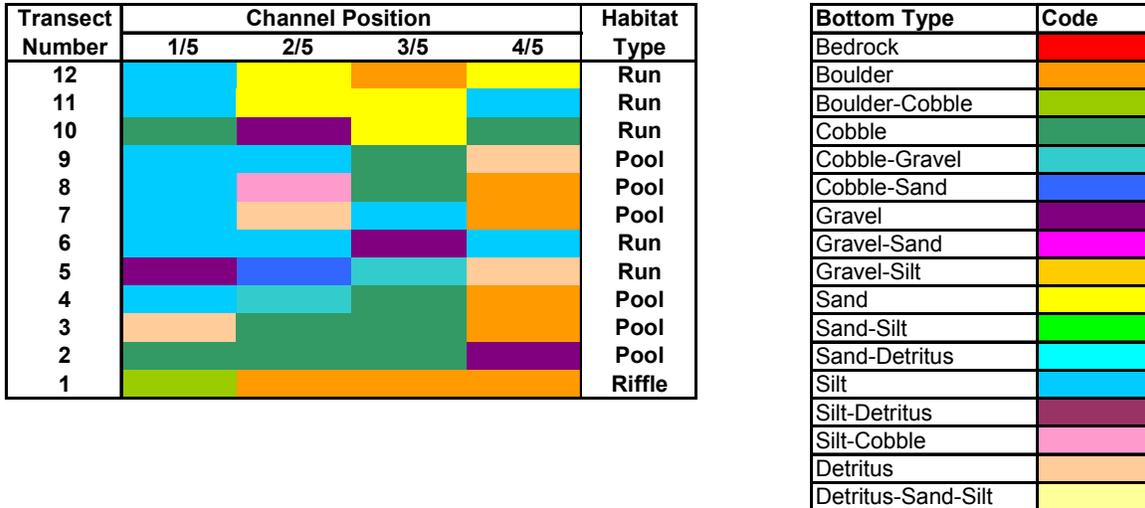
Cobble and boulder bottom substrates were common at this site. Several large areas of silt and sand were also encountered. Even in run areas, current was not strong enough to remove the deposited silt from the stream. Gravel deposits were infrequent and scattered throughout the site.

Figure 27. Bottom sediment map and key for transects at the Jambo Creek location. Transect 1 is the furthest downstream sampling location.

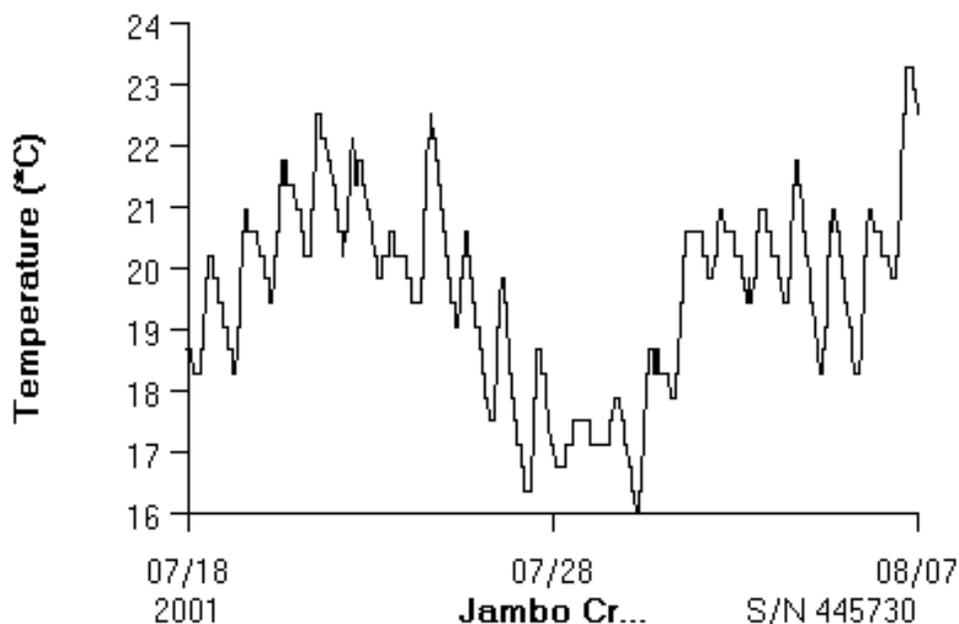
Figure 28, documents the diurnal temperature for Jambo Creek at Jambo Creek Road, during August of 2001. Water temperatures during the monitoring ranged from 16 C. to 24 C. (Figure 28). The observed temperature regime could limit the success of coldwater species in the section of river.

Figure 28. Diurnal temperature for Jambo Creek at Jambo Creek Road, during the August of 2001.

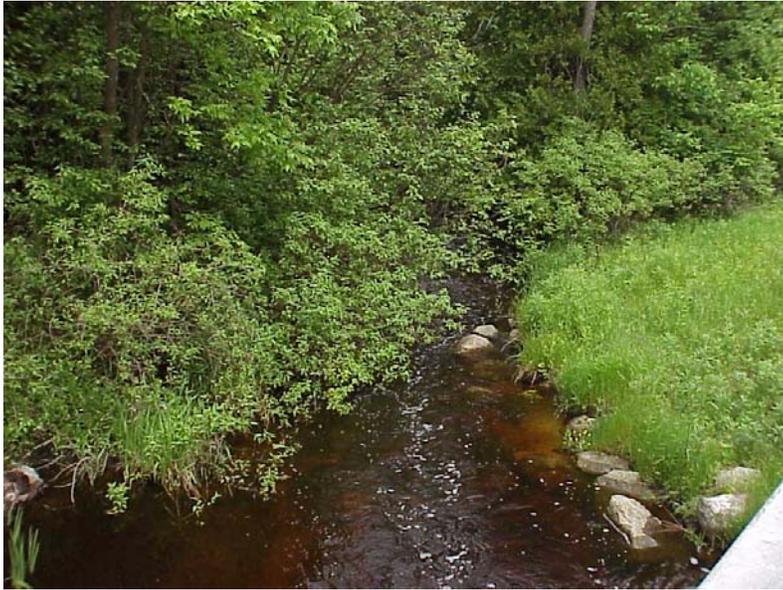
This site was located just upstream of County Highway BB, and ran through mostly woodland with some shrubs (N44-19.660, W087-38.206 to N44-19.738, W087-38.068). The survey section averaged 7.0 meters in width and was 245 meters in length (Appendix 1). The gradient was 1.2 meters per kilometer and had a sinuosity of 1 to 1.5. The study reach of the river was mostly runs and pools with few riffles (Figure 29).

Figure 29. Looking upstream at Tisch Mills Creek from County Highway BB.

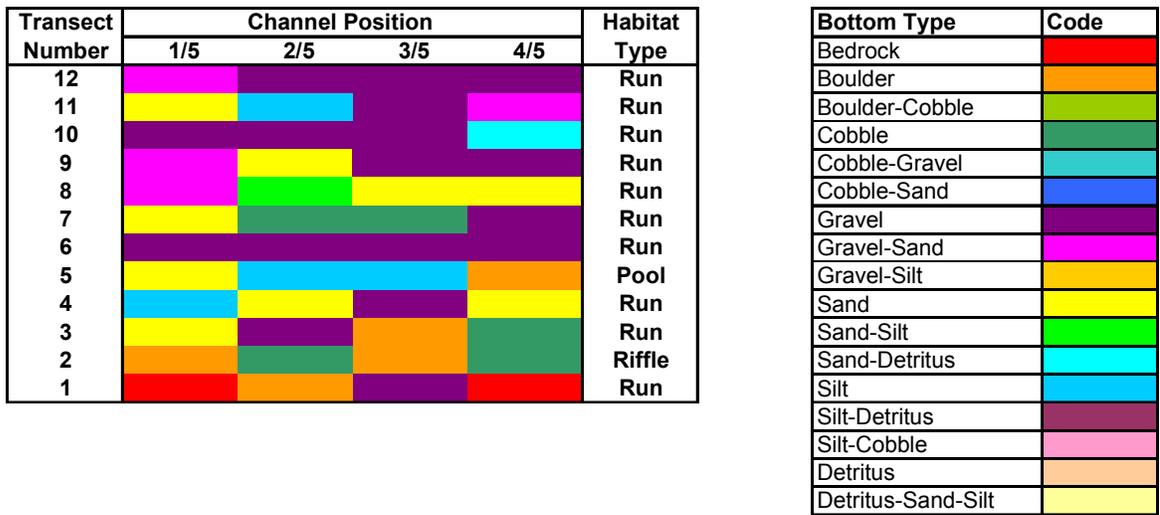
The bottom sediments at this location were extremely rocky. Most of the transects contained gravel, cobble, boulders and a small amount of bedrock. Sand was common but silt and detritus were uncommon except in pools or where deposited behind obstructions in the river.

Figure 30. Bottom sediment map and key for transects at the Tisch Mills Creek location. Transect 1 is the furthest downstream sampling location.

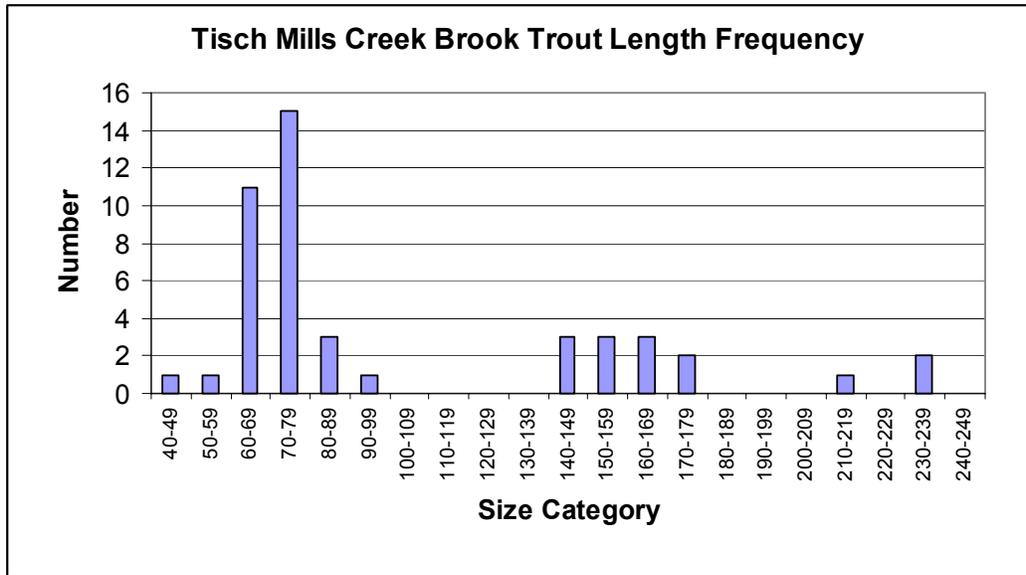
Table 13. Brook Trout length frequency collected from Tisch Mills Creek during August 2001.

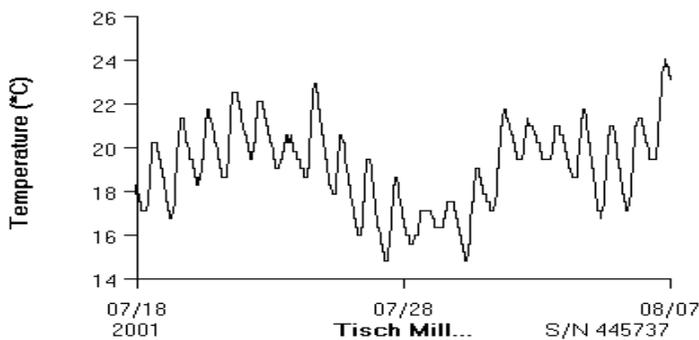
Figure 31 documents the diurnal temperature for Tisch Mills Creek at CTH during August of 2001. Although the maximum diurnal temperature approached 24 Centigrade (the upper preferred limit for brown trout), trout were common in the stream segment sampled.

Figure 31. Diurnal temperature for Tisch Mills Creek at CTH BB during August of 2001.

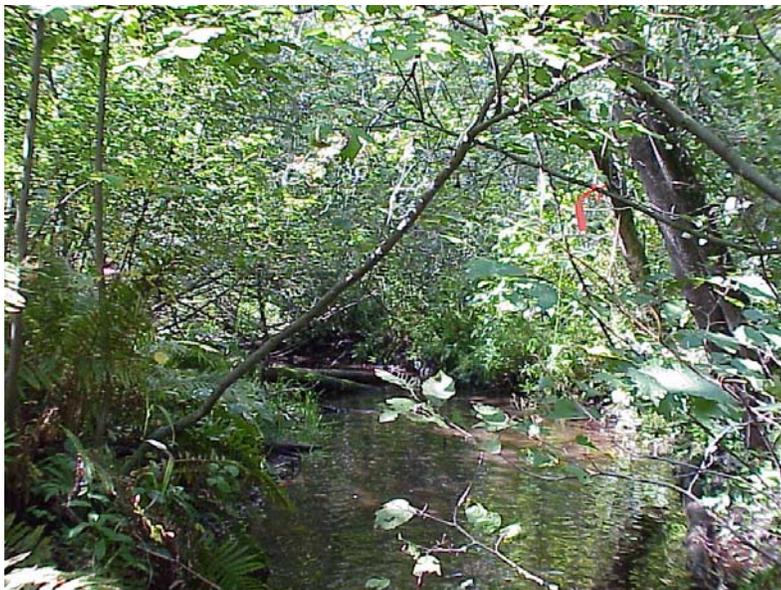
This site was located just upstream of Highway 29, and ran through mostly shrubs, woodland and some wetland (N44-26.616, W087-37.758 to N44-26.664, W087-37.768). The survey section averaged 4.0 meters in width and was 140 meters in length (Appendix 1). The gradient was 2.2 meters per kilometer and had a sinuosity of 1 to 1.5. The study reach of the river was mostly runs and pools with a lesser amount of riffle (Figure 32).

Figure 32. Looking upstream on Krok Creek from the downstream end of the survey station.

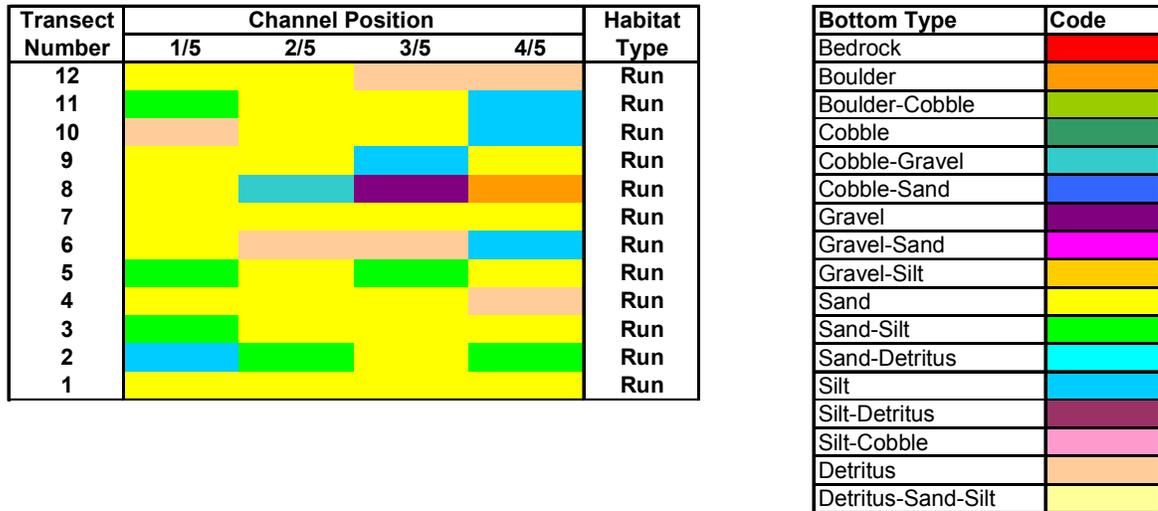
Sand or mixtures of silt or detritus and sand dominated the bottom sediments (Figure 33). Detritus was also commonly encountered, but rock substrates were uncommon.

Figure 33. Bottom sediment map and key for transects at the Krok Creek location. Transect 1 is the furthest downstream sampling location.

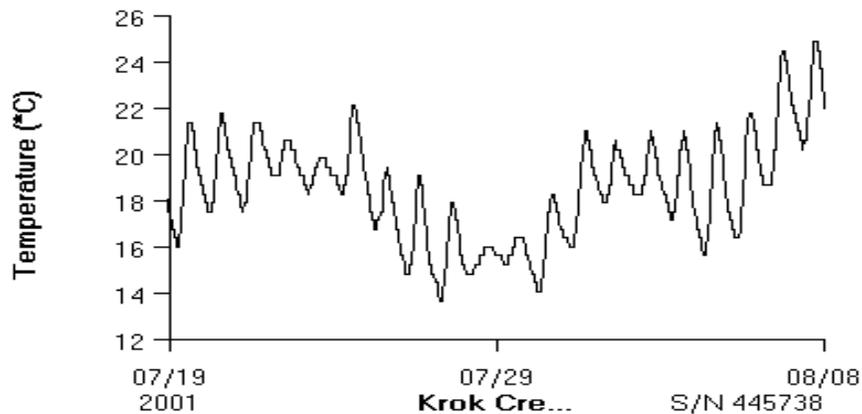
Figure 34 documents the diurnal temperature for Krok Creek at Highway 29 during August of 2001. Maximum diurnal temperatures reached 24 C, which is beyond recommended preferred temperatures for brook trout and brown trout.

Figure 34. Diurnal temperature for Krok Creek at Highway 29 during August of 2001.

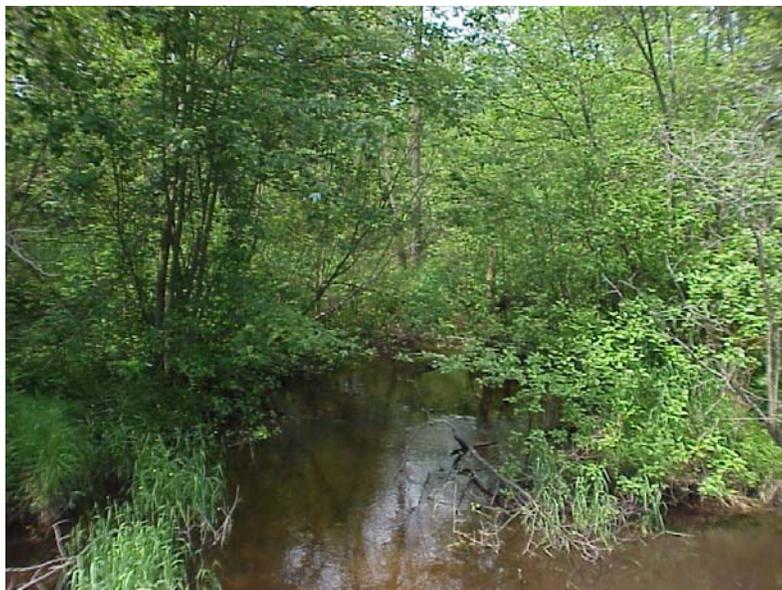
The unnamed tributary site was located just upstream of County Highway J, and ran through mostly meadow and shrubs (N44-24.005, W087-36.095 to N44-24.060, W087-36.112). The survey section averaged 4.0 meters in width and was 140 meters in length (Appendix 1). The gradient was 2.2 meters per kilometer and had a sinuosity of 1 to 1.4. The study reach of the river consisted of runs and pools without any riffles (Figure 35).

Figure 35. Looking upstream of an unnamed tributary to the East Twin River at County Highway J.

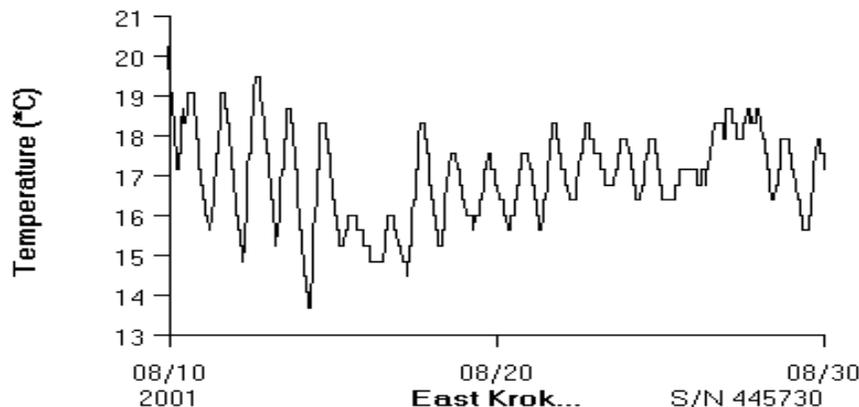
Figure 37. Diurnal temperature for an unnamed tributary flowing out of East Krok and joining the East Twin River less than a mile south of the County Highway J crossing, during the August of 2001.

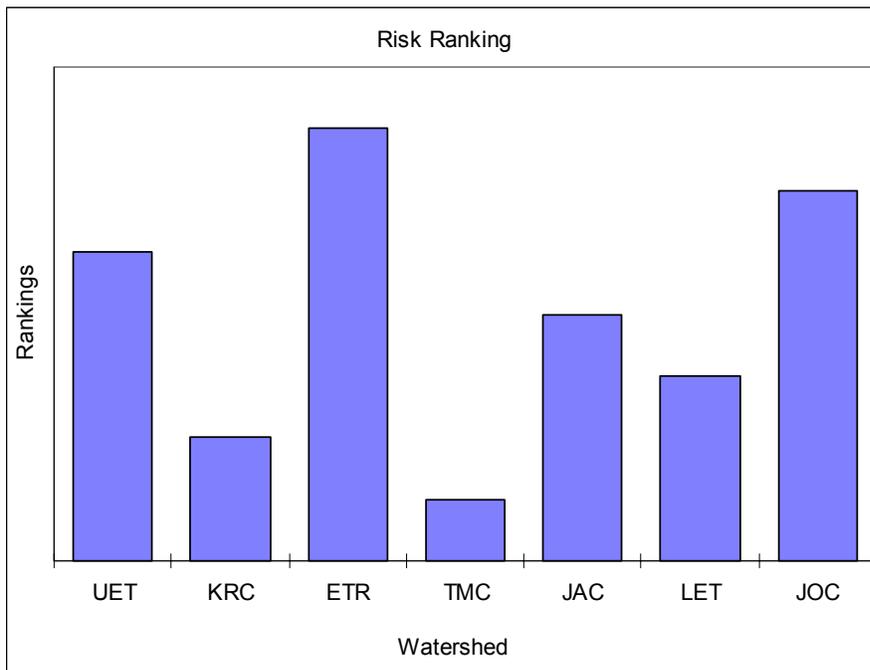
Figure 38. Relative risk ranking to land use impacts of each sub-watershed in the East Twin River basin. The sub-watersheds in the East Twin River basin are the Upper East Twin (UET), Krok Creek (KRC), the East Twin River from the Mishicot Dam to the confluence with Krok Creek (ETR), Tisch Mills Creek (TMC), Jambo Creek (JAC), the Lower East Twin River from Lake Michigan to Mishicot dam (LET) and Johnson Creek (JOC).

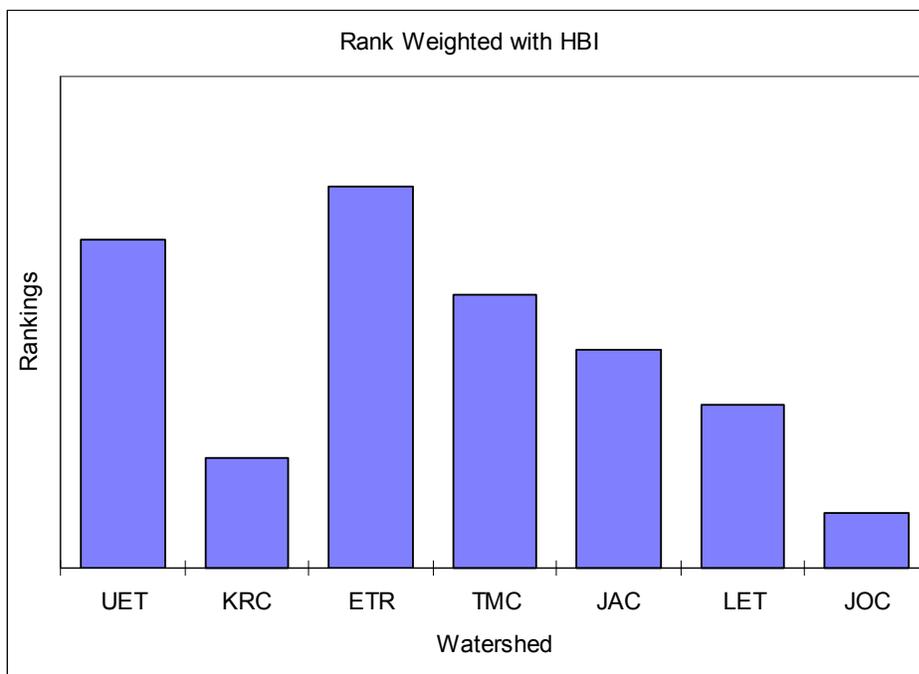
Figure 39. Relative risk ranking based on land use impacts to each sub-watershed as reflected by HBI scores. The sub-watersheds in the East Twin River basin are the Upper East Twin (UET), Krok Creek (KRC), the East Twin River from the Mishicot Dam to the confluence with Krok Creek (ETR), Tisch Mills Creek (TMC), Jambo Creek (JAC), the Lower East Twin River from Lake Michigan to Mishicot dam (LET) and Johnson Creek (JOC).
